**WEST CARROLL TOWNSHIP WATER  
AND SEWER AUTHORITY DAM  
(BAKERTON DAM)**

**PHASE I INSPECTION REPORT  
NATIONAL DAM SAFETY PROGRAM**

**JUNE 1978**

NDI No PA 436

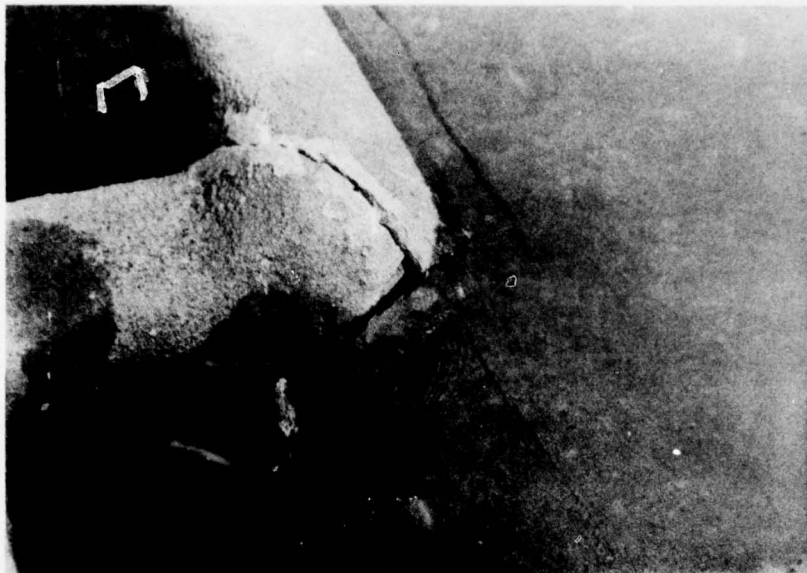
CLOSEUP VIEW OF LARGE CRACK AT NORTHERN  
END OF RECTANGULAR DROP-TYPE SPILLWAY

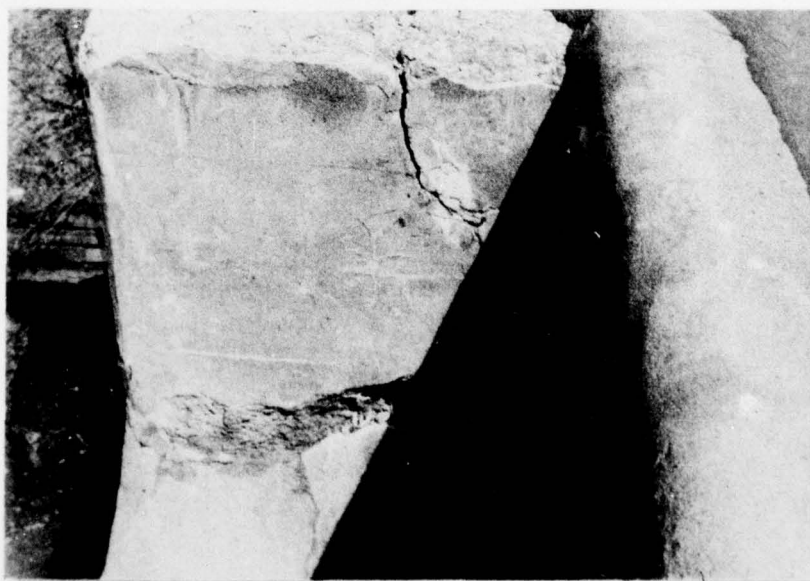
VISUAL EXAMINATION OF	OBSERVATIONS	REMARKS OR RECOMMENDATIONS
SURFACE CRACKS CONCRETE SURFACES	Numerous area of this dam had been gunited and many surface cracks could be seen in the gunite and original concrete. (Steel reinforcing exposed).	Repair or pressure mortar all cracks surface area to prevent further deterioration.
STRUCTURAL CRACKING	Only at the overflow low flow spillway area; construction joint separation due to ice build up	Repair area to prevent complete separation.
VERTICAL AND HORIZONTAL ALIGNMENT	OK There doesn't seem to be any apparent movement, both horizontal and vertical.	
MONOLITH JOINTS	No evidence of expansion joints. Monolith joints of sloping slab has some slight seepage.	
CONSTRUCTION JOINTS	Some deterioration at several locations	Repair deteriorated areas
STAFF GAGE OF RECORDER	None

CLOSEUP VIEW SHOWING CONCRETE DETERIORATION  
AT NORTHERN END OF EMERGENCY SPILLWAY

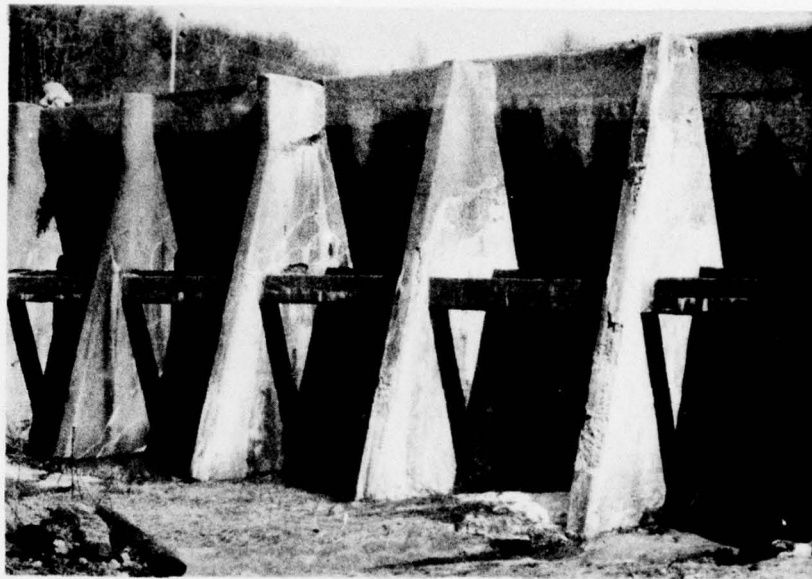
(2) Concrete structure: Based on our observations the concrete and guniting is disintegrating in many locations. There are wet spots and leakage coming through the deck slabs in many locations, but this has been happening ever since the structure was filled with water. There is a slight separation between the deck slab and baffle for the low flow spillway. This separation appears to have been caused by ice build-up. This area was completely blocked with ice during our initial field inspection on March 8, 1978. The concrete in this region, the top of baffle and the top of the concrete buttress, are lightly reinforced, but the failure of this top section in our opinion would not lead to total collapse of the structure. The loss of the steel reinforcing section due to the continuous corrosion conditions over the years and the existing strength of the concrete could become factors at peak flood conditions. The steel reinforcing that we observed showed no major loss of section. The concrete structure at this time shows no outside sign of distress, but the question arises as to what's the condition of the steel reinforcing and concrete that's covered with earth. The right portion of the structure has had sulfurized water permeating through the earthen embankment and weep holes possibly since it was constructed or for some time. The reason for this condition is that during construction a seam of coal at elevation 1810 was unexpectedly uncovered. This area was of much concern at the time, but it was finally decided by the engineers and inspector (from DER records) that the material was impervious enough so the core wall was not extended into the coal laden material. The major area of concern is the differential in earth pressure at several buttresses. The buttresses are not reinforced for the lateral forces which are presently being generated from

GENERAL VIEW OF CENTER SECTION OF DAM  
SHOWING CONDITION OF CONCRETE DAM

(1) The Owner retain a competent consulting engineering firm to make a feasibility study and cost analysis to determine whether the existing dam is economically feasible to repair, or should it be replaced by another dam downstream from the existing facilities. The study should be completed as soon as possible, with immediate action concerning the remedial solution to follow in the near future.

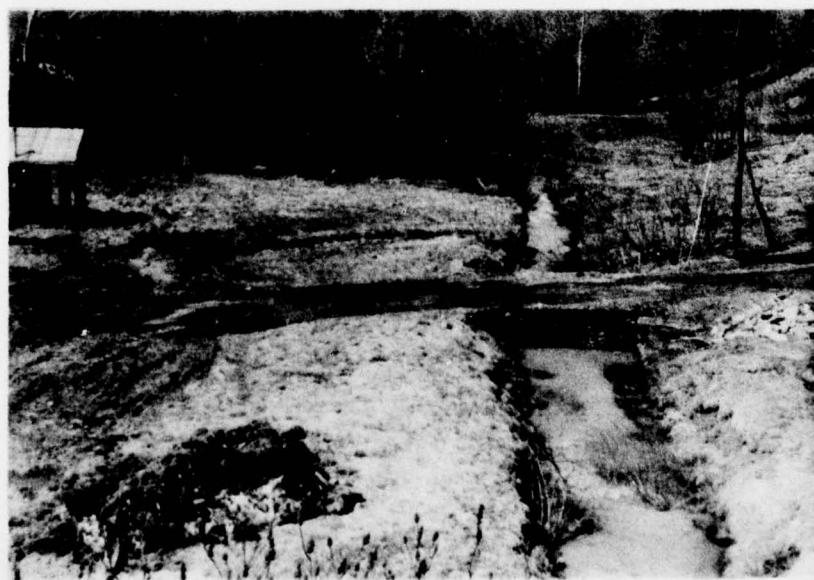
VISUAL EXAMINATION OF	OBSERVATIONS	REMARKS OR RECOMMENDATIONS
CONCRETE WEIR	None	
APPROACH CHANNEL	None	
DISCHARGE CHANNEL	Channel is the existing ground that contains gravel and boulders, some scour adjacent to concrete mattress and on low flow channel banks; trees growing in channel.	Should have larger material such as riprap placed and trees removed
BRIDGE AND PIERS	None

TYPICAL VIEW OF DOWNSTREAM CHANNEL  
WITH CHLORINATION BUILDING AT LEFT
